BLACKSTONE RIVER BASIN
AUBURN, MASSACHUSETTS

STONEVILLE POND DAM
MA 00126

PHASE I INSPECTION REPORT
NATIONAL DAM INSPECTION PROGRAM

AUGUST 1978

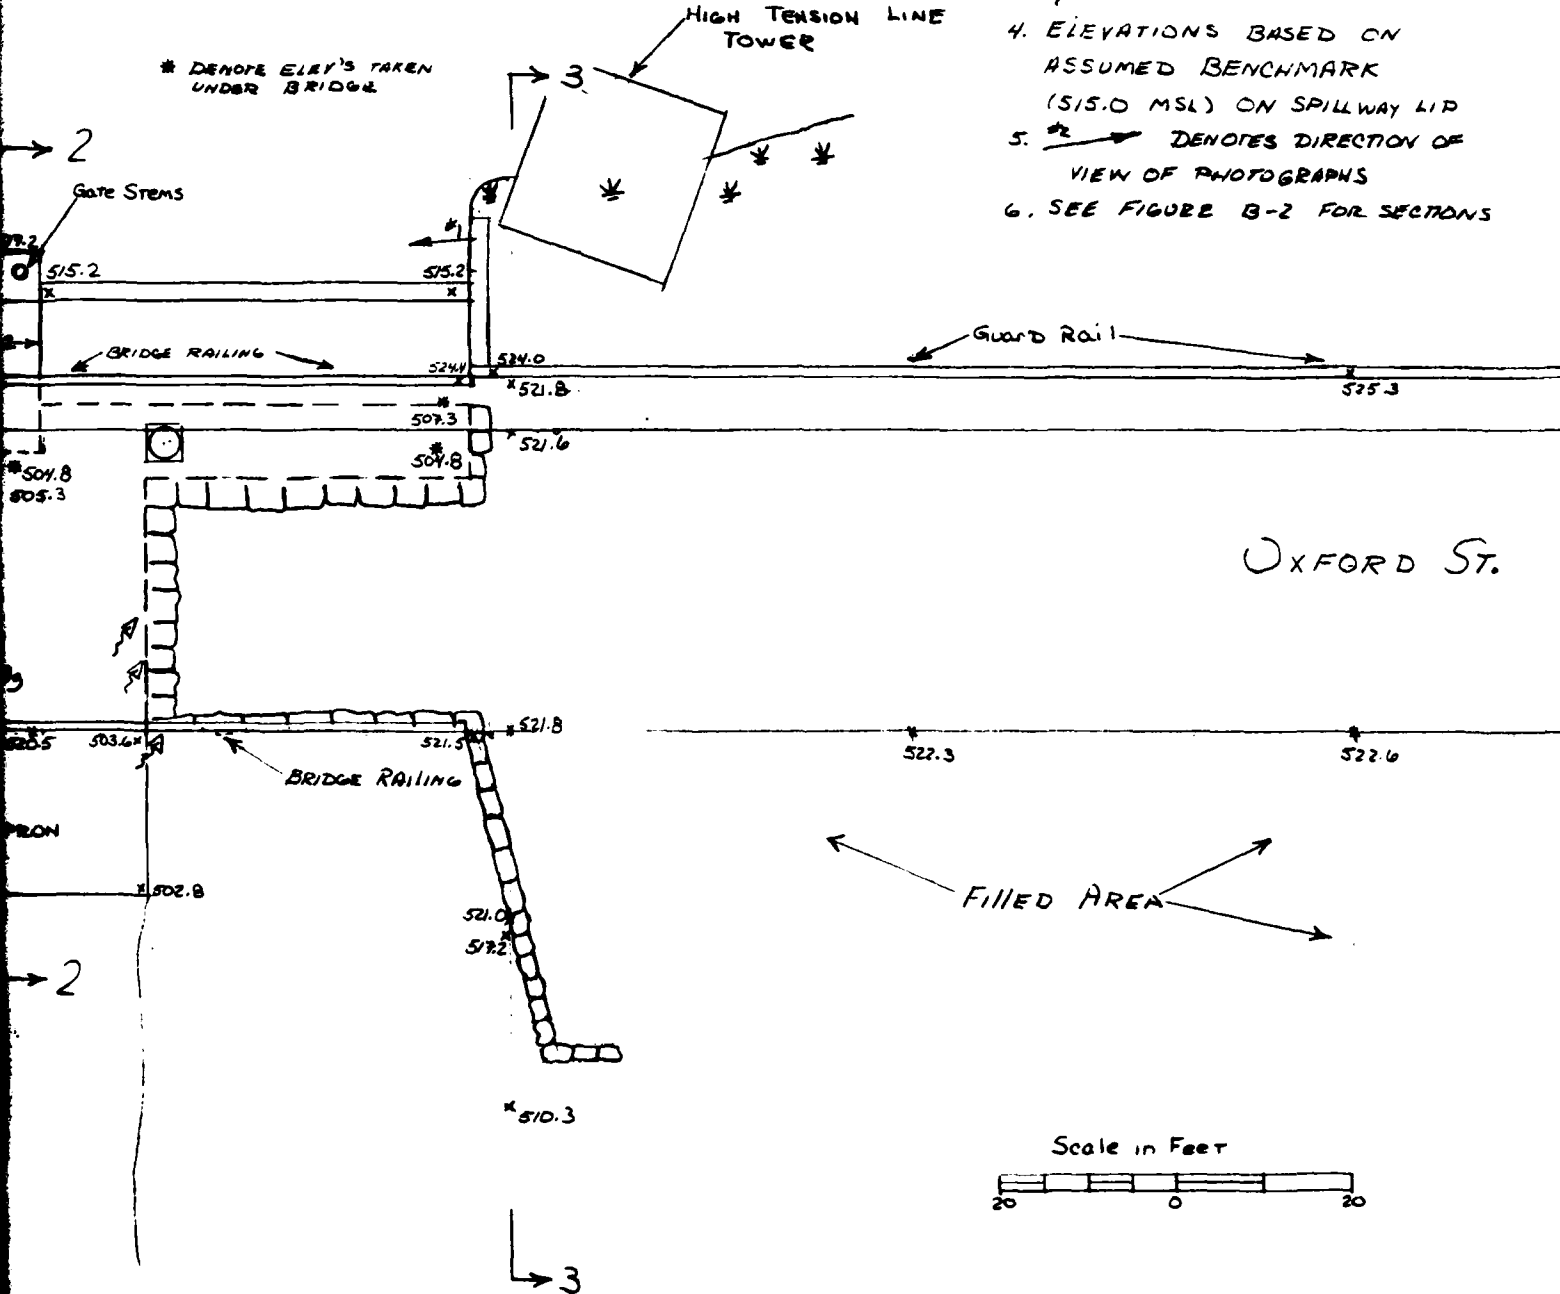
FIGURE B-1 PLAN OF DAM

- NOTES:
1. INFORMATION SHOWN BASED ON FIELD SURVEY OF JULY 31, 1978
 2. * 515.9 REFERS TO ELEVATIONS LOCATED BENEATH BRIDGE
 3. Δ DENOTES SEEPAGE
 4. ELEVATIONS BASED ON ASSUMED BENCHMARK (515.0 MSL) ON SPILLWAY LIP
 5. * → DENOTES DIRECTION OF VIEW OF PHOTOGRAPHS
 6. SEE FIGURE B-2 FOR SECTIONS
